# Manhole Inspection Summary

Manhole # S1100\_011MH

Insp Date: **8/13/07 2:14 PM**

**Location** Address: **2501 ELLAMONT AVE**

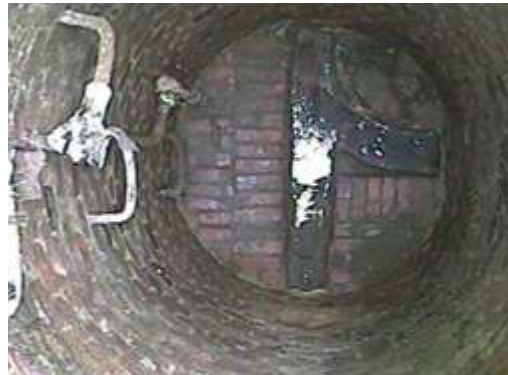
Top View

☒ **Evidence Of Surcharge** Depth: **7** (ft.) ☐ Active Surcharge Present

EVIDENCE OF SURCHARGE

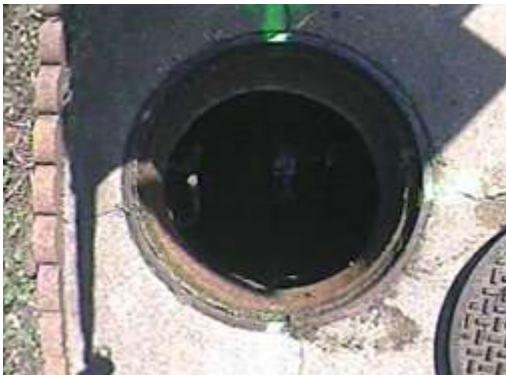
Top View

Offset: **3** (in.)

FRAME OFFSET

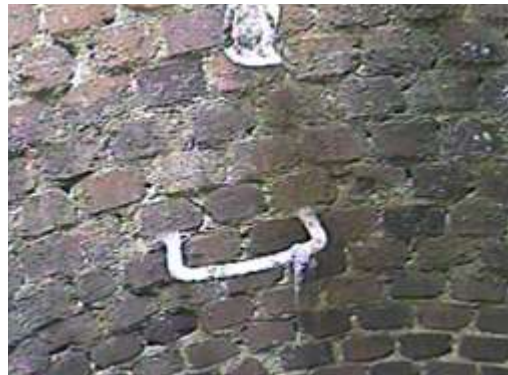
Defect 1

Count: **5** Missing: **0** ☒ **Corroded**

SURCHARGE, CORRODED STEPS

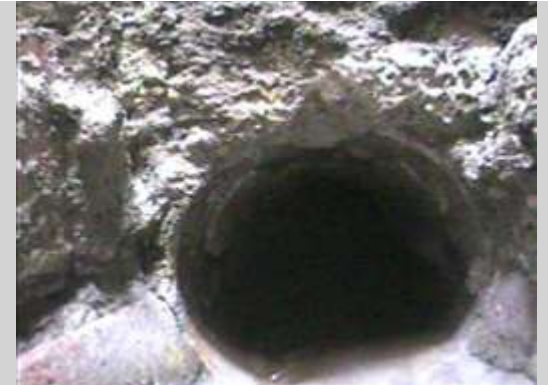
12 O'Clock Outflow

8 in. Circular Gravity Sewer  
Pipe Out @ 12 O'Clock

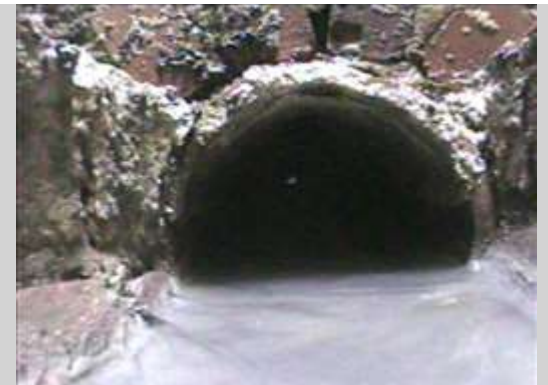
3 O'Clock Inflow

8 in. Circular Gravity Sewer  
Pipe In @ 3 O'Clock

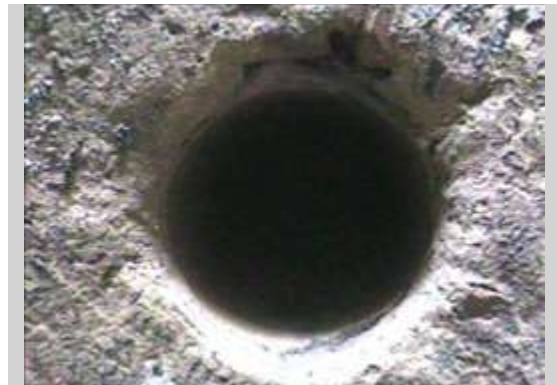
Drop In @ 3 O'Clock

Drop: **Outside Direct**

Drop Condition: **Open**

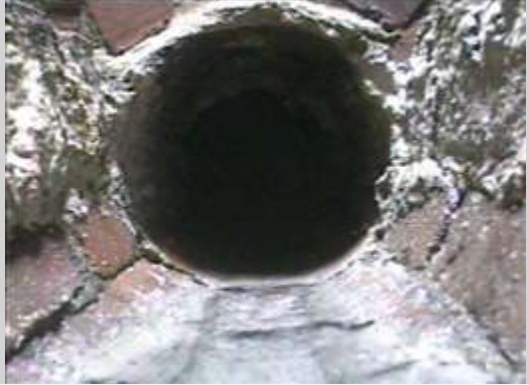
6 O'Clock Inflow

6 in. Circular Gravity Sewer

Pipe In @ 6 O'Clock
